QUALITY ASSURANCE FOR DEEP FOUNDATION ELEMENTS

Edwin J. Kase¹ and Timothy A. Ross²

NSA Geotechnical Services, Inc., 15000 W. 6th Ave., Ste. 100,
Golden, Colorado, 80401 ¹edkase@nsageotech.com
²timross@nsageotech.com

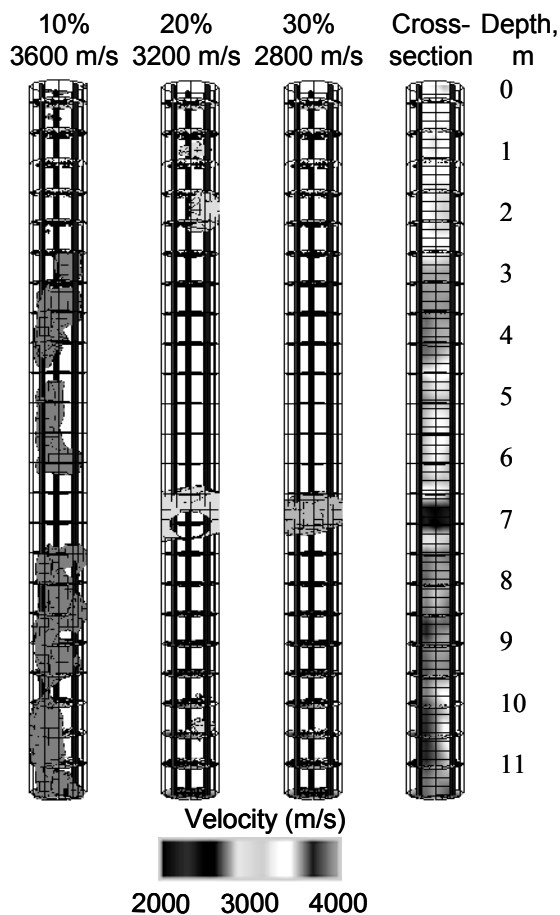
Figure 1. Cross-section Tubes 1 & 2 – Abutment 2, Shaft 4 (A2-4).

The CSL logs from abutment 2 shaft 4 (A2-4) indicated a significant signal delay between all tubes at a depth of approximately 6 to 7 m from the top of the shaft. A signal velocity delay of about 14%, 29%, and 50% was recorded between access tubes 1-2, 1-3, and 2-3, respectively. Based on these CSL test results, it was determined that a significant zone of deficient concrete existed in A2-4, and a remediation strategy was required. The standard procedure to assess the problem would be to obtain core samples from the anomalous zone to physically inspect the concrete, to confirm the actual location, and to grout encountered deficient zones. Since the CSL logs did not indicate the size, geometry, and severity of the defect, a three-dimensional velocity tomographic analysis of the A2-4 shaft using the CSL data was used to produce an image of the geometry and location of the anomaly. The objective of this investigation was to accurately define the geometry and location of the anomalous area, propose a plan for corrective action, and determine the effectiveness of the recommended plan.

In reviewing the CSL data, the average ultrasonic apparent velocity was calculated to be approximately 3,660 m/s. The three-dimensional images indicated most of the area within the shaft had a velocity greater than the average that indicates sound concrete. The zones with velocity contours of 10% (velocity of 3,294 m/s in green) and 20% (velocity of 2,928 m/s in blue) reduction were plotted. A minor zone of about 10% reduction was depicted in the upper part of the shaft between 0.5 m and 2.5 m,

and a 20% reduction zone that extended across the entire shaft diameter was depicted between 6.6 m and 7.5 m depth. After reviewing the tomographic images (Figures 1 through 3), the defects were located

Core inspection indicated that no defective concrete was encountered during the coring in the SE core hole (tubes 2-3). However, the SW coring (tube 2-3) encountered a weak zone 0.15 m long between 6.5 m and 6.65 m below the top of the shaft. The anomaly consisted of a pocket of clean, well-graded, yellow-brown sand in one-half of the core. The sand pocket abruptly terminated in good concrete.

Further analysis of the CSL data with the three-dimensional tomography techniques was conducted to determine the percent in the velocity deviation that should have been contoured to match the core results. The data were reprocessed, and it was determined that the sand pocket coincided with the 30% velocity reduction and not the 20% as specified in the guidelines.

A pile repair procedure was developed with the objective to improve the defect zone in the A2-4 drilled shaft. Permeation grouting to improve the strength and reduce the permeability of the low-density zones within the shaft was recommended. After the successful grouting of the A2-4 shaft, CSL retesting was performed using the standard procedures. The CSL retest results indicated a minor signal velocity reduction at a depth of approximately 6 m from the top. The velocity reduction ranged from 7% for the tube pair 1-2 to about 16% for tube pairs 1-3 and 2-3. The average velocity was estimated at 3,800 m/s

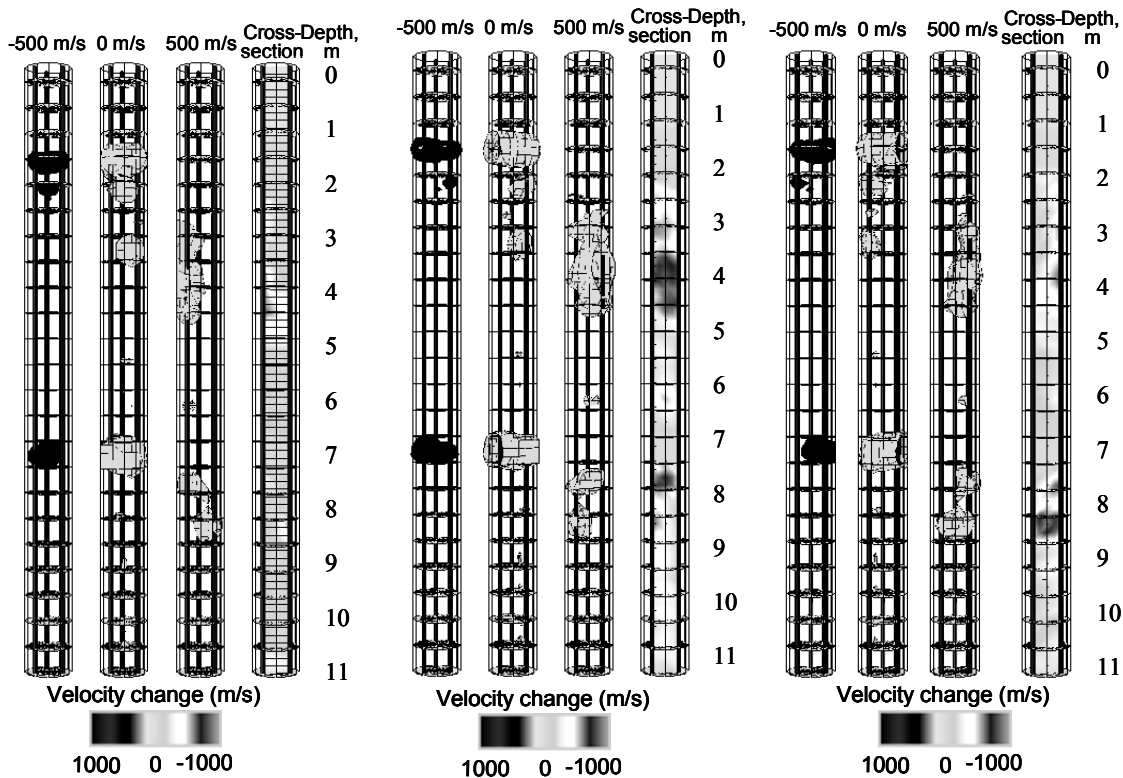
for pairs 1-2 and 2-3, and 3,900 m/s for pair 1-3. The results indicate that the grouting procedure had improved the concrete density within the anomalous zone and reduced the intensity of the defect, but did not completely eliminate the defect. Based on the retest results and the location of the defect within the drilled shaft, the drilled shaft was acceptable for further bridge construction. Difference tomograms between the signals obtained from the pre-grouting and post-grouting tests were calculated and are presented in Figure 4 through 6 as tomograms representing cross-sections between access tube pairs. These tomograms show areas of velocity improvement in three-dimensional contours.

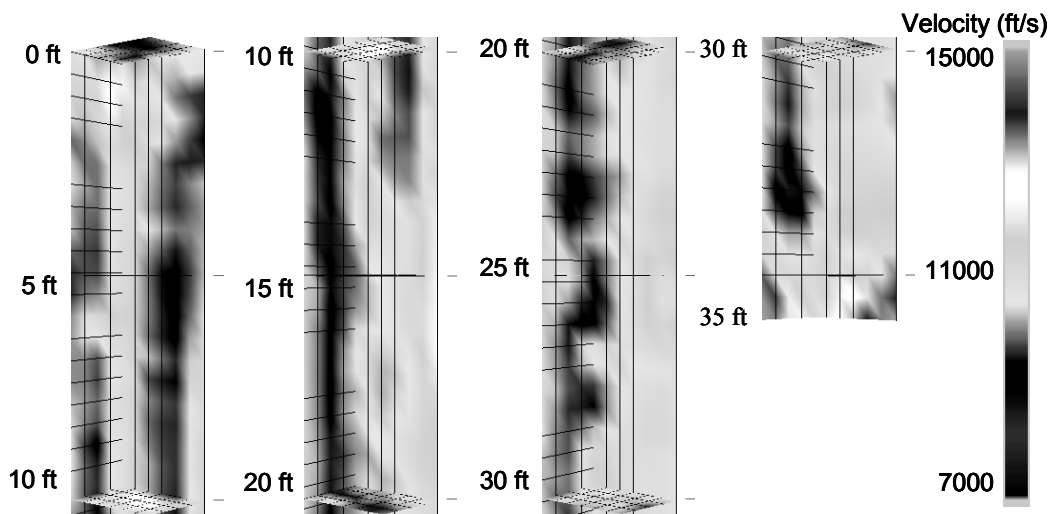
Figure 7. Holes: 4-1-2, 0 ft to 35+ ft.

Figures 7 and 8 show the perimeter panels defined by holes 4-1-2 and 4-3-2, respectively. Figures 9 and 10 show the diagonal panels defined by holes 4-2 and 1-3, respectively. In these four figures, three zones are shown that have velocities lower than 2,600 m/sec (purple zones). Of these three zones, the one within the top 5 ft of the column must be discounted due to the lack of data from hole 4, and the zone between 4 ft and 8 ft only affects the perimeter of the column.

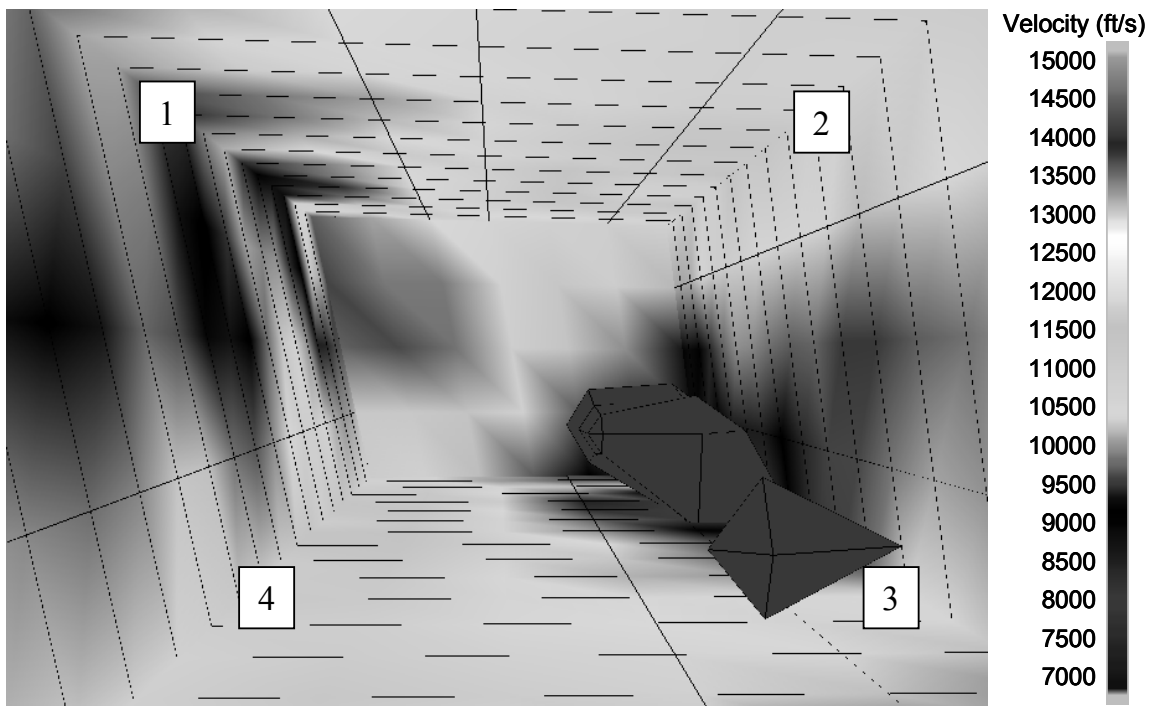
Figure 11. Depth: 22.5-27.5 ft, Contour 8,000 ft/s.

Images were generated showing three-dimensional views down the column at 5-ft intervals. Figures 11 and 12 are views down the column showing velocity contours for 2,450 m/s, indicating concrete that is possibly inferior in quality. The four boreholes define the perimeter panels shown, and a horizontal plane is shown at the bottom of the 5-ft interval.
